CONDOMINIUM INSPECTION REPORT

12155 Metro Pkwy

Fort Myers, FL

Property Inspection Report

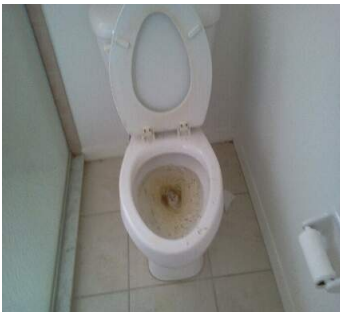
2.

Location: Main Bathroom **System:** Plumbing **Condition:** Toilet valve runs on when tank is full

Explanation: The toilet is observed to continue to run on when the tank is full.

Impact Consequences: This condition creates unnecessary waste of water and the noise of the continually running water can be an annoyance. The toilet valve does not achieve its intended function of turning off the water supply fully when the tank is full.

Recommended Action: Repair
