HOME INSPECTION REPORT

12155 Metro Pkwy

Fort Myers, FL

Property Inspection Report

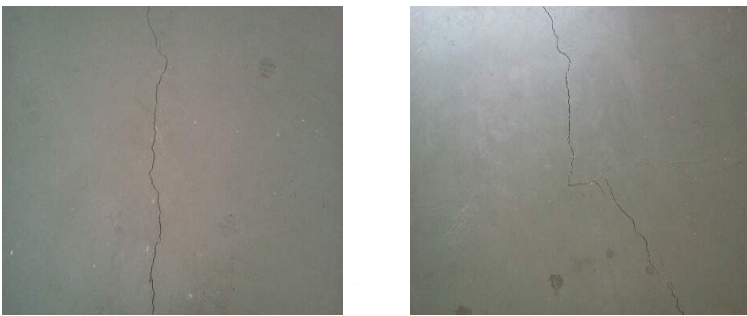
1.

Location: Garage **System:** Exterior **Condition:** Garage concrete floor displays typical settlement

Explanation: Settlement of the garage concrete pad is an indication of insufficient pad thickness. Other causes may include soil compaction soils with low bearing capacity and ground heave. Settlement as a condition by itself does not usually result in garage structure issues. Settlement combined with other structural concerns often indicates the garage as a whole may no longer be structurally sound.

Impact Consequences: Settlement cracks in garage floor should be monitored for change over time. Should cracks result in possible trip hazards a specialist should be consulted for repair.

Recommended Action: Review

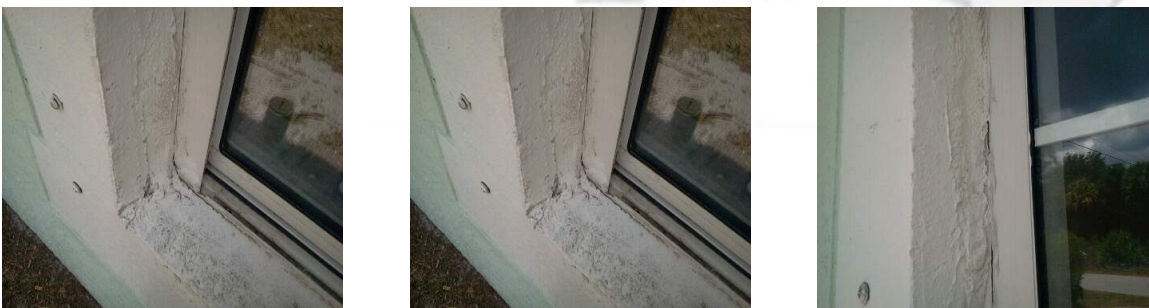
2.

Location: Throughout **System:** Exterior **Condition:** Window caulking is

deteriorated

Explanation: The window caulking is observed to be deteriorated. Caulking that is cracked embrittled or missing requires preventative maintenance actions to ensure the window frames will maintain a weathertight seal at the junction areas of window frame through the exterior wall.

Impact Consequences: Caulking at window frames serves several functions including preventing air water and pest infiltration and restricting heat loss or gain through the exterior wall. Moisture has the greatest potential for damage; unintended water infiltration into the house can cause significant damage to surfaces and property and if not corrected may lead to damage and rot to structural elements. Caulking repairs are required at the noted location(s) and should be performed at the earliest opportunity. Preventative maintenance should include reviewing and repairing exterior caulking at doors windows and wall penetrations at least twice a year.

Location: Throughout **System:** Exterior **Condition:** Window caulking is deteriorated

Explanation: The window caulking is observed to be deteriorated. Caulking that is

cracked embrittled or missing requires preventative maintenance actions to ensure the window frames will maintain a weathertight seal at the junction areas of window frame through the exterior wall.

Recommended Action: Repair

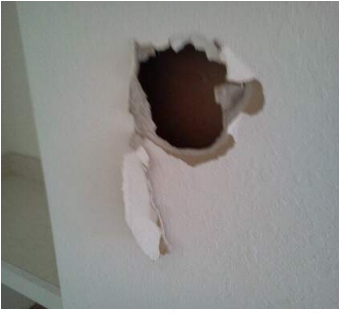
1.

Location: Living Room **System:** Interior **Condition:** Physical impact damage noted in wall surface finish.

Explanation: Physical damage is noted to the wall surface finish. Damage of this nature is usually the result of impact. No structural damage is suspected.

Impact Consequences: The nature of the damage is typically cosmetic in nature. Surface repairs should be considered to establish a visually acceptable wall finish.

Recommended Action: Repair

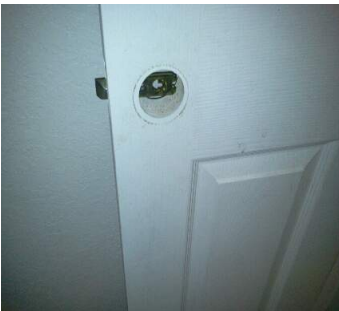
2.

Location: Hall **System:** Interior **Condition:** Interior door has missing door latch hardware

Explanation: Hardware required for latching or locking the door is missing. Absence of this hardware impairs function at this door.

Recommended Action: Repair replace or install as required

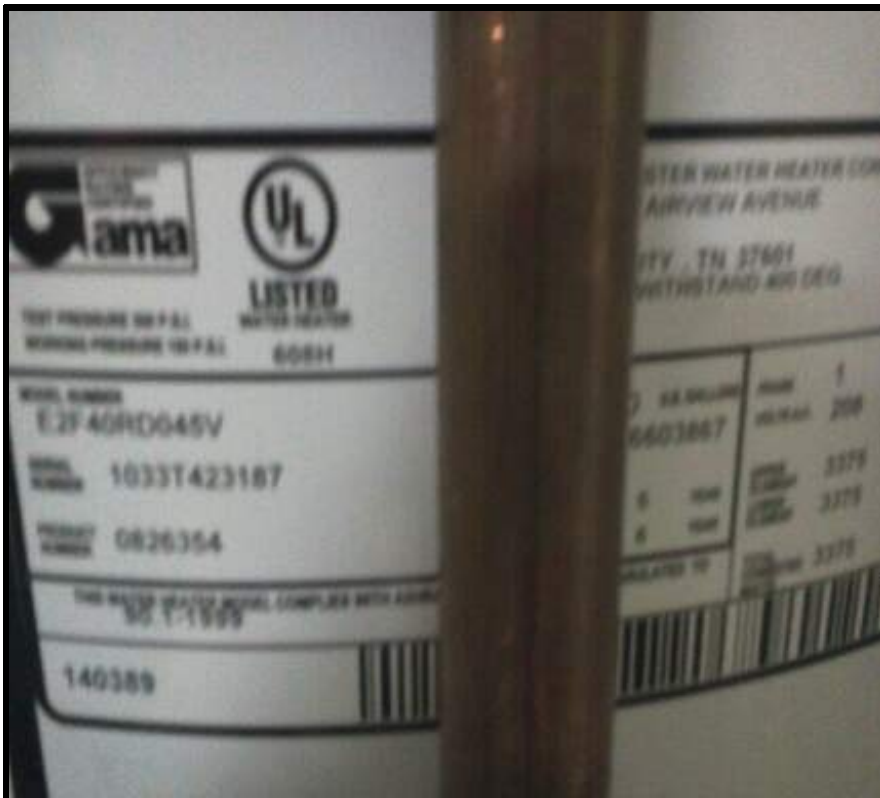
Water Heater Label

Make	Model#	Serial#	Type	Fuel	Shut-off	Age	Size	Venting
U.S. Craftmaster			Tank	Electricity	Breaker	5-10	40	NA

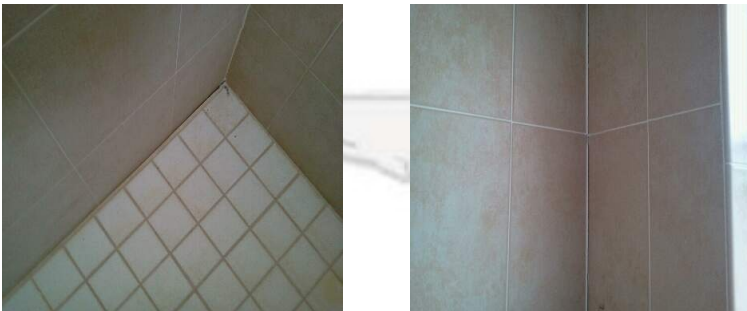
1.

Location: Main Bathroom **System:** Plumbing **Condition:** Shower enclosure has grout that is incomplete or open between tiles

Explanation: The purpose of grout is to prevent water penetration between the edges of tiles at the shower area. Grouting is observed to be inadequate to meet the intended requirements for sealing against water leakage.

Impact Consequences: Grouting is required to complete the cosmetic appearance of a tiled area and to serve to prevent water from seeping between tiles and into walls and floors. Failure to provide effective grout application can result in damage and costly repairs due to water leaks behind and below finished areas.

Recommended Action: Repair

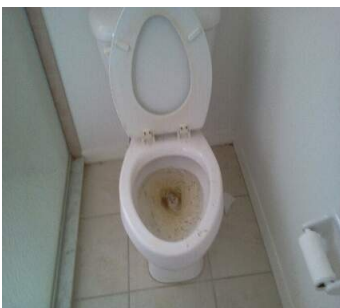
2.

Location: Main Bathroom **System:** Plumbing **Condition:** Toilet valve runs on when tank is full

Explanation: The toilet is observed to continue to run on when the tank is full.

Impact Consequences: This condition creates unnecessary waste of water and the noise of the continually running water can be an annoyance. The toilet valve does not achieve its intended function of turning off the water supply fully when the tank is

Recommended Action: Repair
