123 Future st.  
Unit:5  
Fort Myers, Fort myers  
33966  
USA

# Uniform Mitigation Verification Inspection Form

# Photo Report

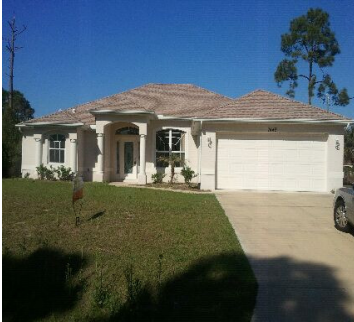
1.

**Location:** Exterior Front **System:** Wind Mitigation **Condition:** Front  
**Explanation:** Photo of Front showing Glazed and Non Glazed openings  
**Impact Consequences:** Style of roof should be evident if accessibility allows  
**Recommended Action:** Predominant Roof Covering should be viewable if access allows

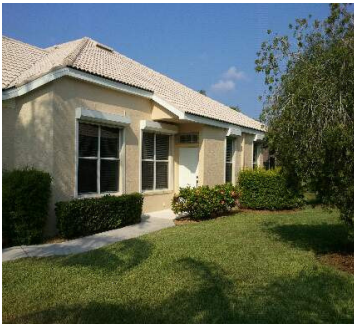
2.

**Location:** Exterior Left **System:** Wind Mitigation **Condition:** Left  
**Explanation:**  
**Impact Consequences:**  
**Recommended Action:**

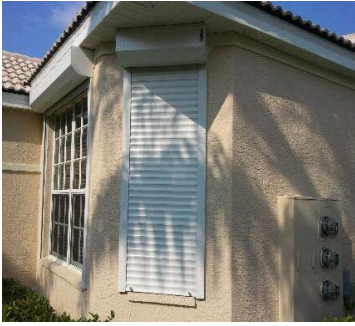
3.

**Location:** Exterior Back **System:** Wind Mitigation **Condition:** Back  
**Explanation:** Photo of back showing Glazed and Non Glazed openings  
**Impact Consequences:** Style of roof should be evident if accessibility allows  
**Recommended Action:** Predominant Roof Covering should be viewable if access allows  
[Click here to find out more about this item](#)

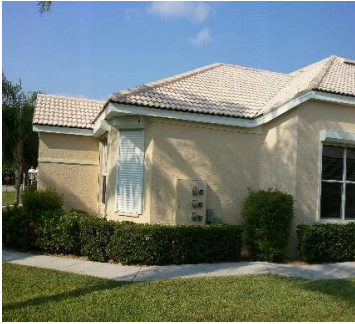
4.

**Location:** Exterior Right **System:** Wind Mitigation **Condition:** Right  
**Explanation:** Photo of right Side showing Glazed and Non Glazed openings  
**Impact Consequences:** Style of roof should be evident if accessibility allows  
**Recommended Action:** Predominant Roof Covering should be viewable if access allows  
[Click here to find out more about this item](#)

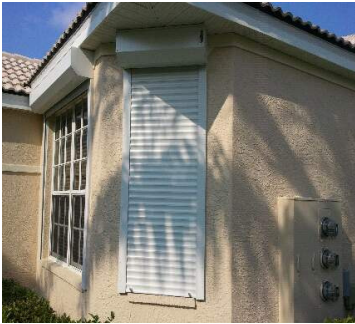
5.

**Location:** Exterior Right **System:** Wind Mitigation **Condition:** Photo showing details of Window Coverings  
**Explanation:** No Comment  
**Impact Consequences:** No Comment  
**Recommended Action:** No Comment  
[Click here to find out more about this item](#)

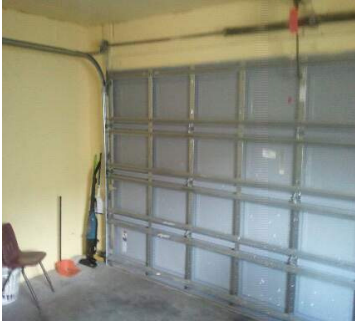
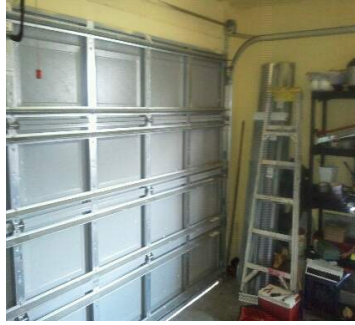
6.

**Location:** Garage **System:** Wind Mitigation **Condition:** Photo showing details of Garage Door

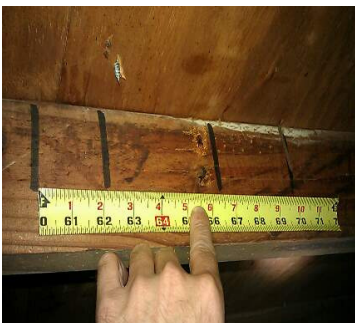
8.

**Location:** Attic **System:** Wind Mitigation **Condition:** Photo showing detail of a Field Nailing

**Explanation:** Evidence of weather or not Roof sheathing is attached to the roof truss and or rafter

(spaced a maximum of 24" o.c.) by staples or 6d nails spaced at 12" in the field.

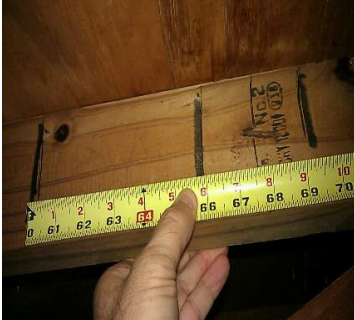
9.

**Location:** Attic **System:** Wind Mitigation **Condition:** Photo showing detail of a Edge Nailing

**Explanation:** Evidence of weather or not roof sheathing attached to the roof truss and or rafter (spaced a maximum of 24" o.c.) by staples or 6d nails spaced at 6" along the edge.

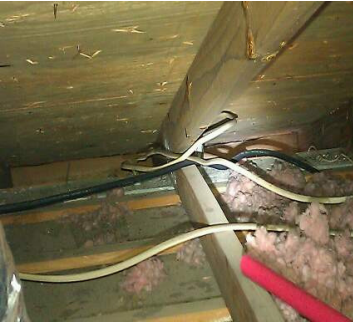
11.

**Location:** Attic **System:** Wind Mitigation **Condition:** Photo showing detail of a Single Wrap Detail

**Explanation:** Single Wraps Metal Straps must be secured to every rafter and or truss with a minimum of 3 nails wrapping over and securing to the opposite side of the rafter and or truss with a minimum of 1 nail. The Strap must be attached to the top plate of the wall frame or embedded in the bond beam in at least one place.

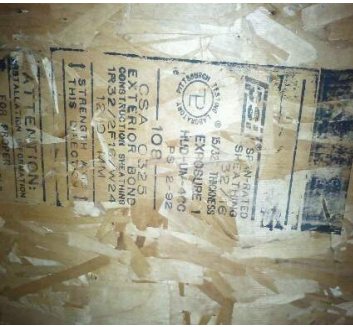
12.

**Location:** Attic **System:** Wind Mitigation **Condition:** Photo showing Roof Sheeting Stamp

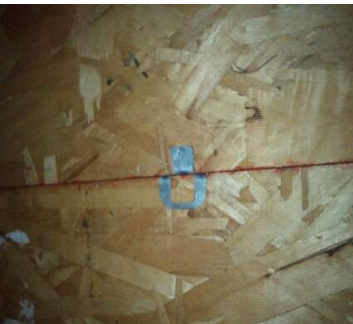
13.

**Location:** Attic **System:** Wind Mitigation **Condition:** Photo showing Roof Sheeting Alignment Clip
